Failure Analysis of a Compressed Natural Gas Storage Cylinder

Liaqat Ali¹, Khalid M. Ghauri¹ and Faiz ul Hasan¹

Abstract

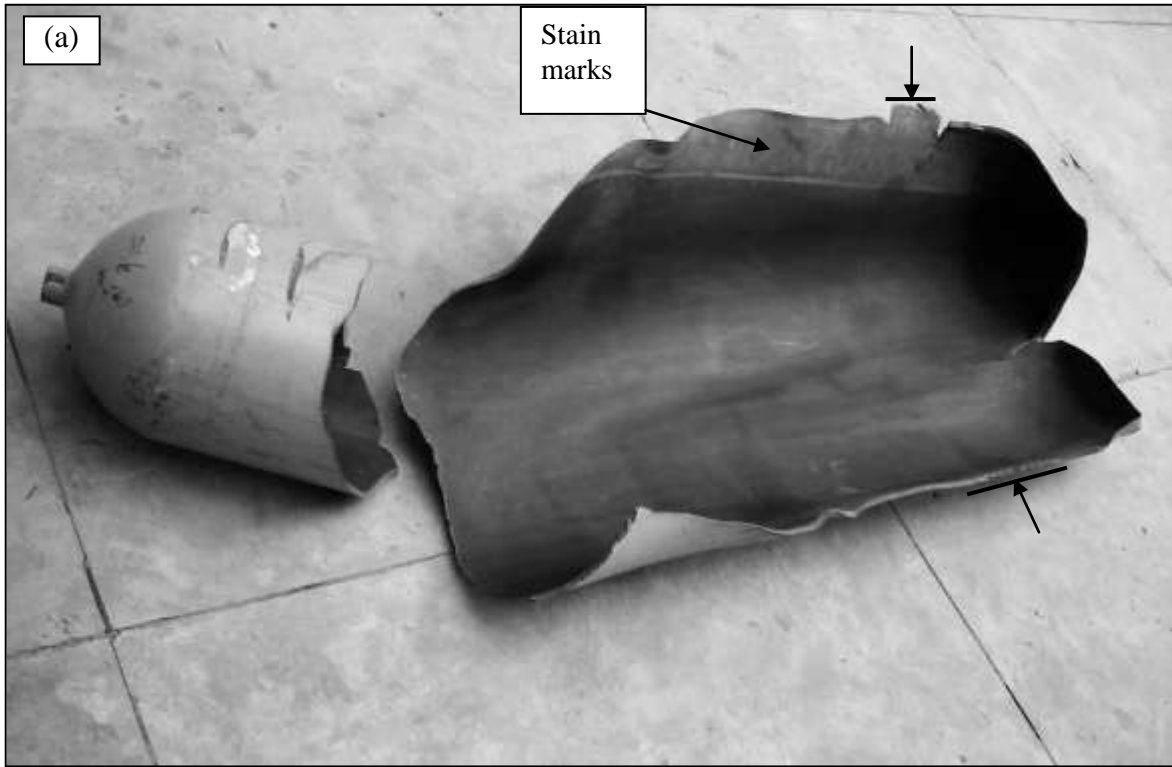
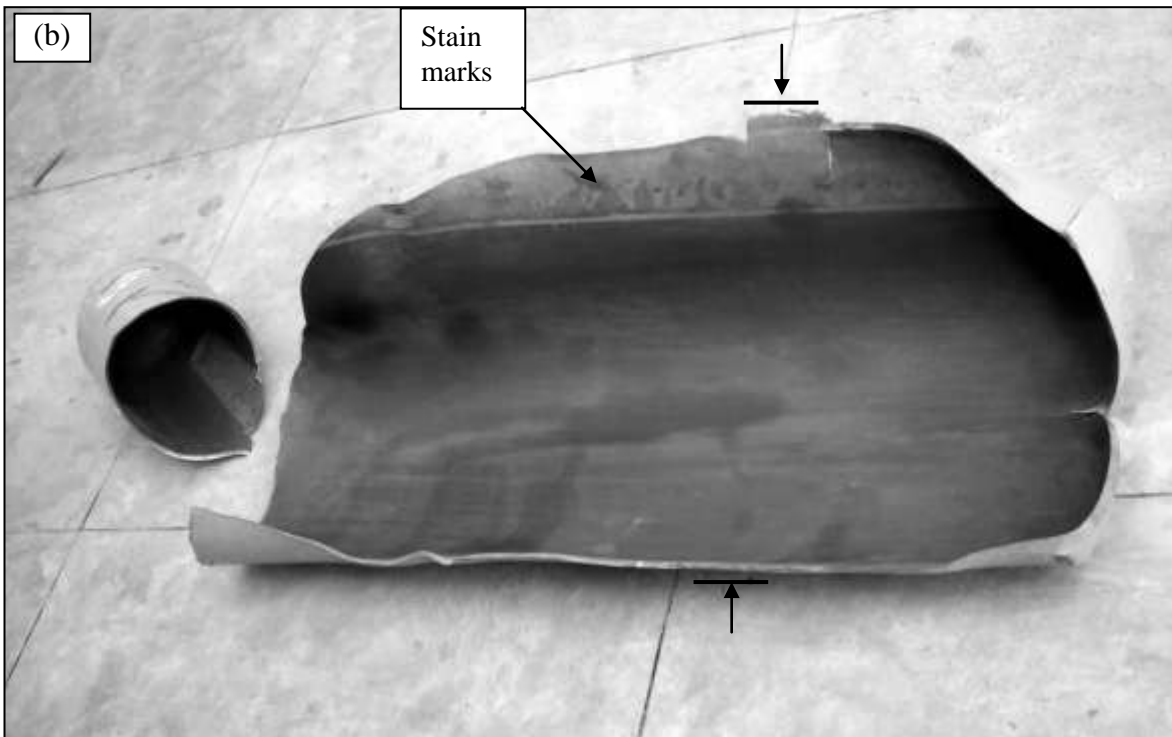
Photographs of the ruptured cylinder are shown in Fig. 1. Visual examination of the fractured surface has shown that the rupture was initiated by the formation of longitudinal cracks on the inside surface of the cylinder, at about the 6 o'clock position on the horizontally mounted cylinder. The region of crack initiation is indicated by an arrowhead in Fig. 1.

Fig.1(a & b) Photographs of the ruptured cylinder indicating (with an arrowhead) the region of crack initiation, as well as the rusted portions on the inside surface.

A close examination of this region showed that the cracking had actually initiated at many different points, as indicated by 'chevron' markings. As many as eight points of origin could be clearly identified within a distance of about 200 mm along the fractured cylinder wall. The remaining part of the fractured surface showed the typical slant ductile overload fracture.

The area around the 6 o'clock position on the inside surface of the cylinder was visibly 'rusted' when compared with the rest of the internal surface of the cylinder. Further examination of this area, shown in Figs. 1 and 2, indicated that the rusting had

A macroscopic examination of the entire fractured surface showed that the cracking had initiated in an approximately 200 mm long region of the cylinder-wall. This region, as indicated in Fig. 1, was oriented parallel to the axis of the cylinder. It should be noted in Fig. 1 that the initial cracks had formed at the edge of the rusted region on the inside surface of the cylinder. Macro-photographs taken from this region are shown in Fig. 3, from which it is evident that a number of cracks had separately nucleated on the inside surface of the cylinder (Fig.3a)

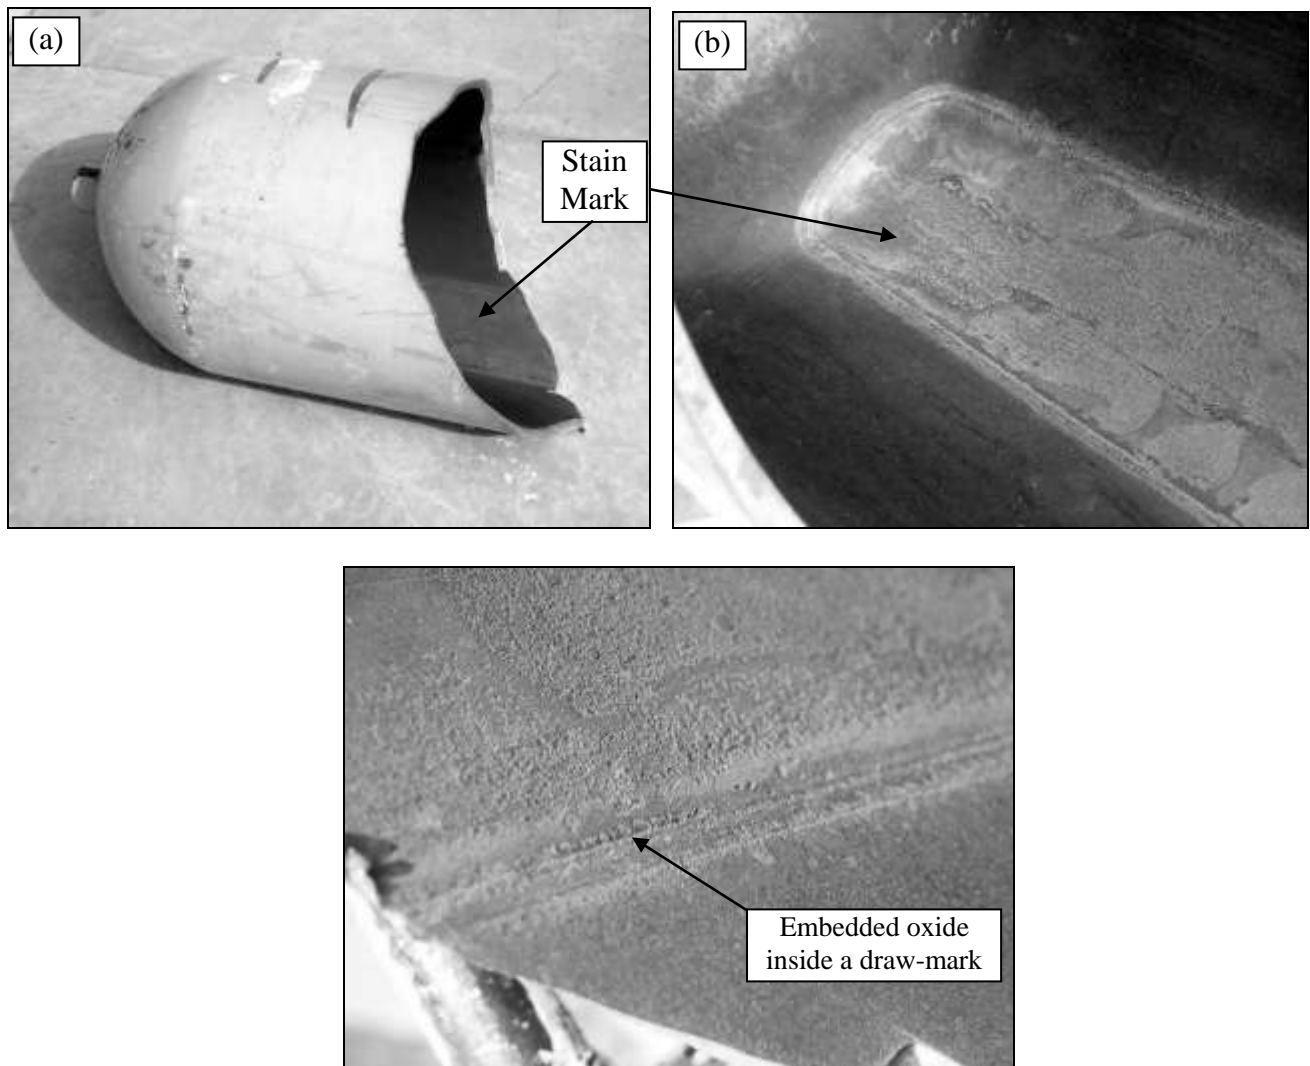
been caused by the collection and stagnation of some liquid (presumably water or some condensate) inside the cylinder while it was lying in the horizontal orientation. The rusted region which was about 100 mm wide ran along the entire length of the cylinder, indicating that approximately 2 liters of the stagnant liquid may have been present in the cylinder at the time of rupture. A detailed macroscopic examination of the rusted region also showed signs of sporadic pitting corrosion in these areas (Fig. 2b and c) which indicated that the liquid / water that had been present in the cylinder was of corrosive character. Unfortunately, no sample of the liquid collected from

Fig.2 (a &b) Photographs showing the stains caused by the stagnant liquid (presumably water) inside the horizontally mounted cylinder. It was estimated that about 2 liters of liquid was present in the cylinder at the time of rupture. (c) Showing the extent of corrosion caused by the stagnant water. The arrowhead points at the embedded oxide (dark-grey) inside a longitudinal draw-mark.

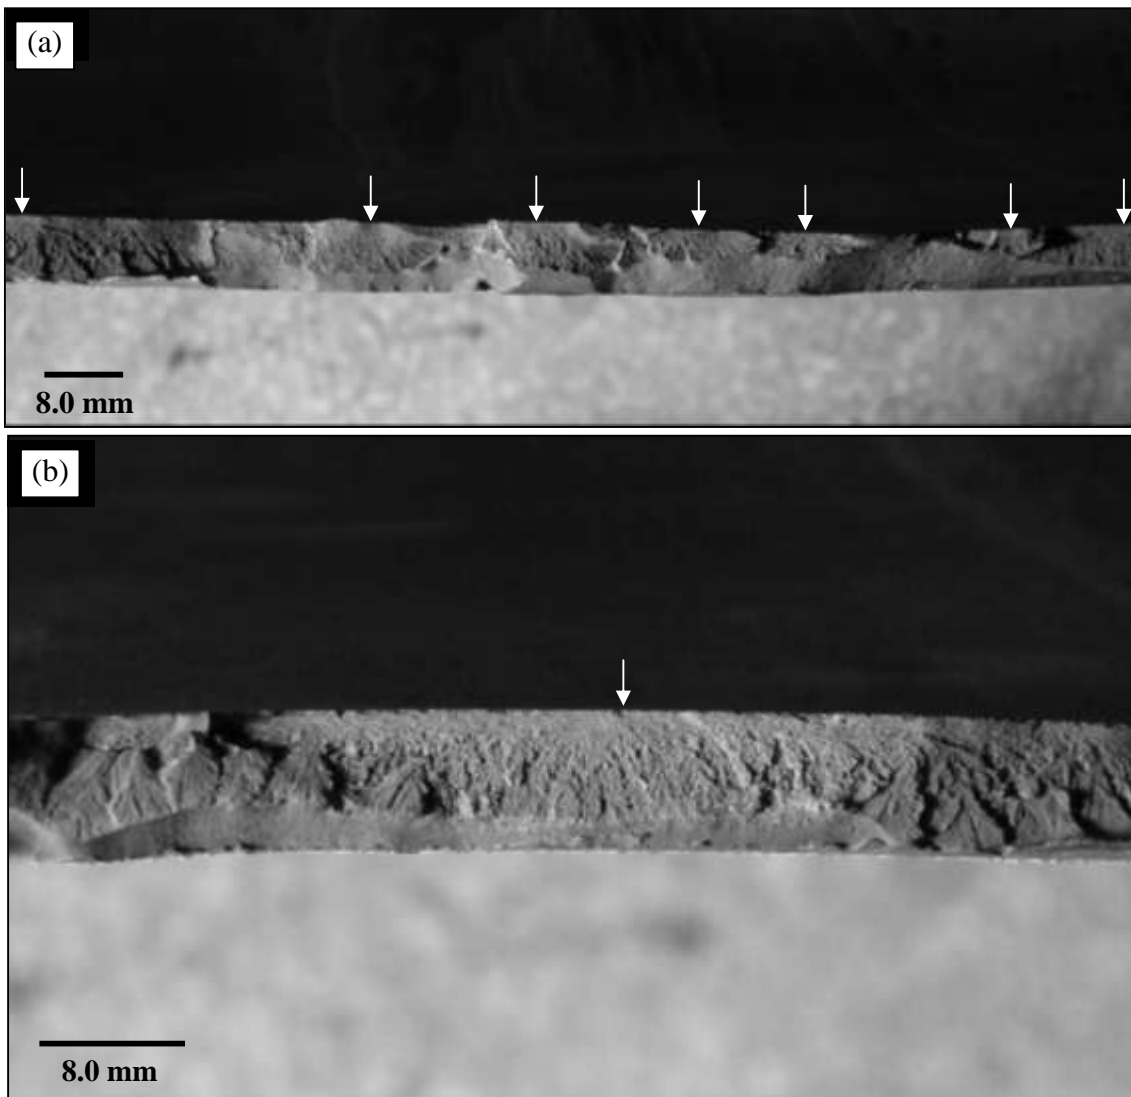
The longitudinal cracks that had initiated the fracture were oriented parallel to the axis of the cylinder and perpendicular to the cylinder wall. These cracks had formed at different planes in close proximity to each other. As many as 8-10 separate longitudinal cracks were present within a length of about 200 mm, indicating that multiple cracking had taken place. It should be noted that when the ruptured cylinder was first examined, about 24 hours after its rupture, there were no signs of any oxidation or corrosion on the surface of the crack.

It was noted that the fracture cracks had formed within the ‘rusted’ region on the inside surface of the cylinder and along a line that was very close to the

Fig.3 (a &b) Macro-Photographs of the fractured surface showing the points of crack initiation on the inside surface of the cylinder.

edge of the rusted portion of the cylinder surface. This observation suggests that corrosion due to stagnant liquid may have played a role in the initiation of the crack. Considering a hoop stress of 45% (hoop stress \cong 445 MPa, calculated according to $\sigma_{hoop} = Pd/2t$ [1], P = pressure, d = diameter and t = thickness) of the yield stress (990 MPa) at the operating pressure of 250 bars in the presence of a corrosive environment, the possibility of stress corrosion cracking (or SCC) appears highly likely [2]. Multiple sites of crack nucleation, as seen in Fig. 3a, are also indicative of stress corrosion cracking [3].

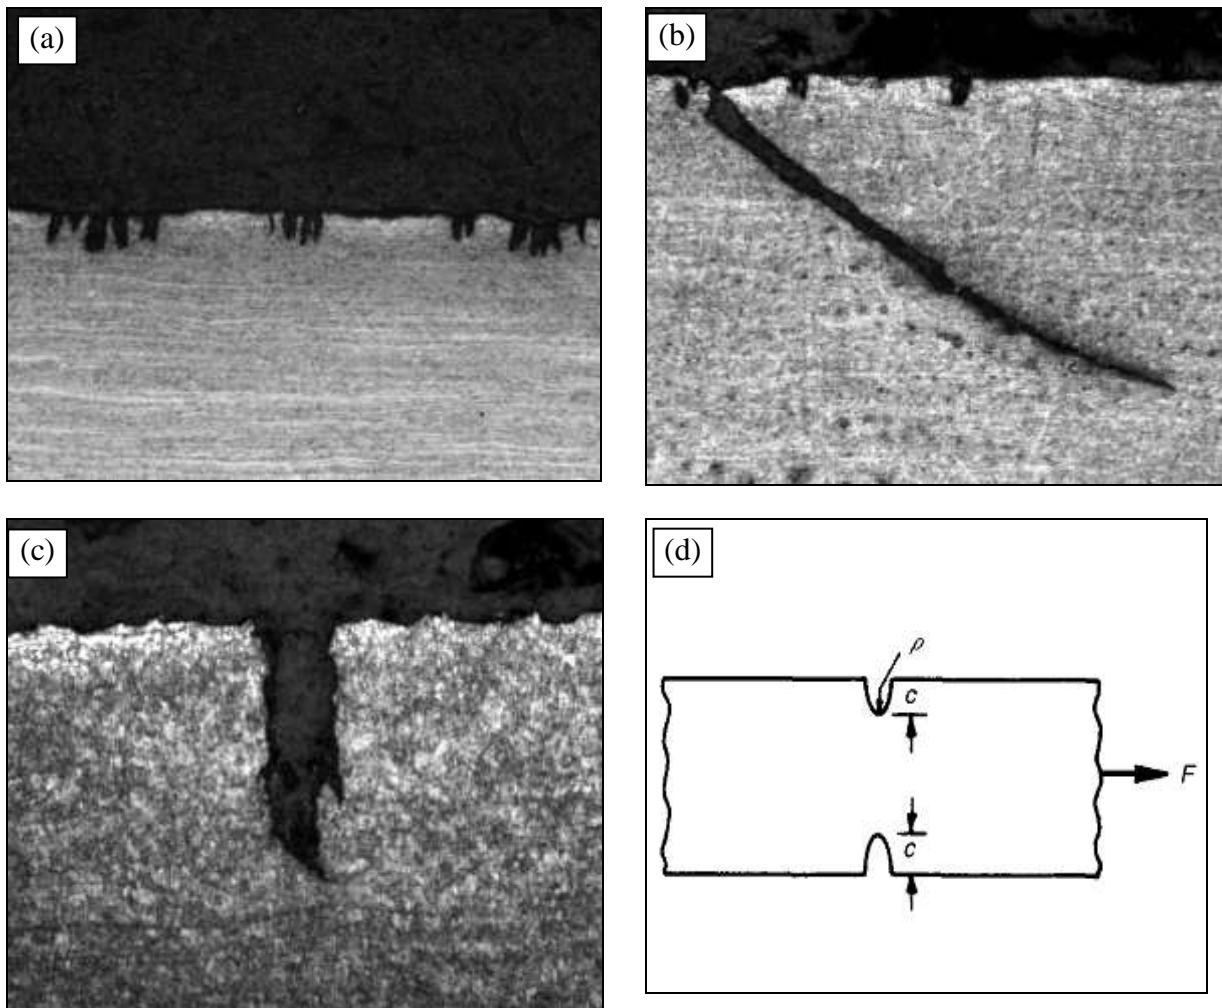
In order to examine whether any further stress-corrosion cracks were present in the areas close to the fracture surface, samples were cut for metallographic examination with surfaces perpendicular to both the plane of the crack and the longitudinal axis of the cylinder; corresponding micrographs are shown in Fig. 4. It can be seen in Fig. 4a that there was a profusion of deep draw-marks on the inside surface of the cylinder. In addition to the draw-marks, a longitudinal ‘fold’ or ‘overlap’ (Fig. 4b), was present very close to the line of the fracture.

Fig.4 Microphotographs taken from the transverse sections showing the depth of the draw marks (a and c) as well as a surface ‘fold’ or ‘overlap’ in (b). It may be noted that no stress-corrosion cracking could be observed to have started at the roots of the draw marks at this stage. (d) Schematic showing the depth and radius of the notch for the calculation of stress concentration factor under tensile force [5].

The depth of the draw-marks, as observed on the sectioned samples (see Fig. 4c), was between 0.35 and 0.4 mm. The observed width of these draw marks was in the range of 0.1-0.16. Such draw-marks can cause stress concentration of sufficient magnitude to become the source of either stress-corrosion-cracking, or fatigue/corrosion-fatigue [3-4]. The stress concentration (SC) factor for some of the draw marks has been calculated according to [5]:

The calculated SC factor values for some of these draw marks are between 2.0 and 2.2, which are in the high range. At this point it can be argued, on the basis of SC factor values, that a high amount of stress can accumulate at the tips of these draw marks and this stress concentration can actively contribute to stress corrosion cracking (SCC)/corrosion-fatigue.

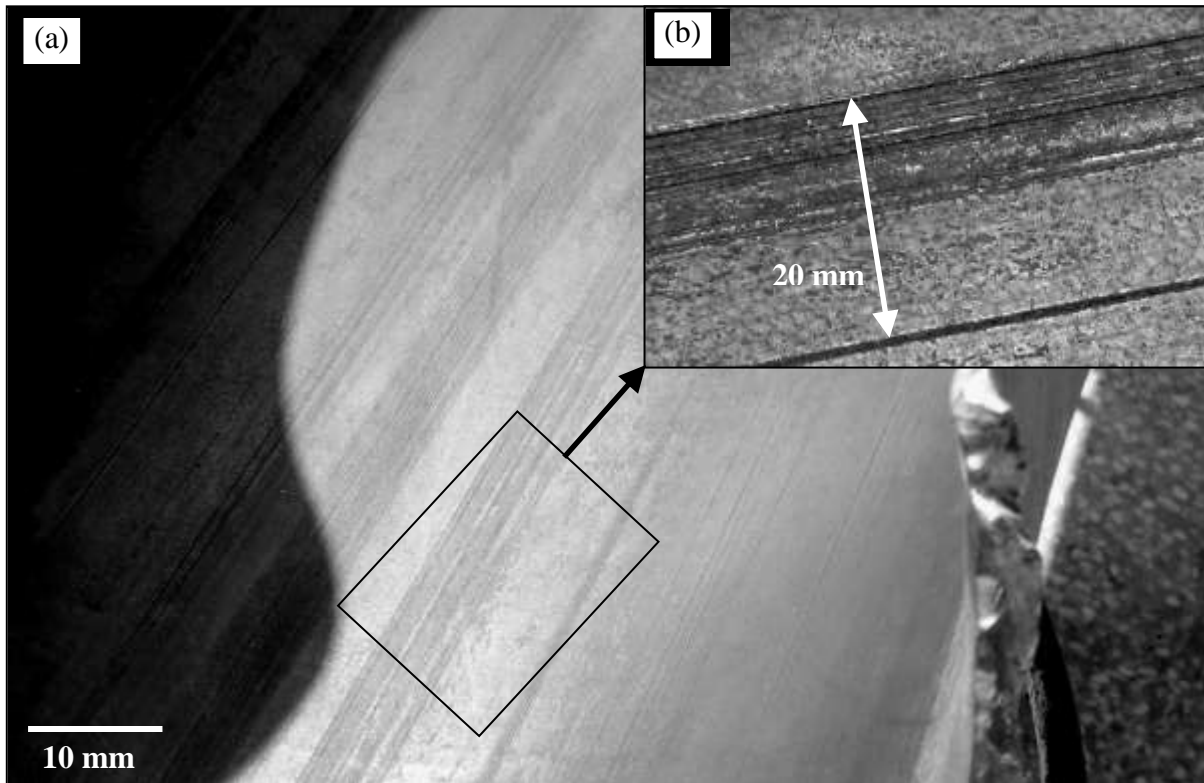
A photograph of the draw-marks as seen on the un-rusted areas is given in Fig. 5. The number (population) and the apparent depth of these draw-marks as seen in Fig. 5 cannot be regarded as a normal and acceptable feature of the deep drawn high pressure cylinders [4].

Fig.5 (a) Photograph showing the longitudinal draw-marks on the inside surface of the cylinder. The apparent depth and the sharpness of some of these draw-marks cannot be regarded as a normal feature of deep drawn cylinders to be used for high-pressure applications. (b) A magnified view of the draw marks.

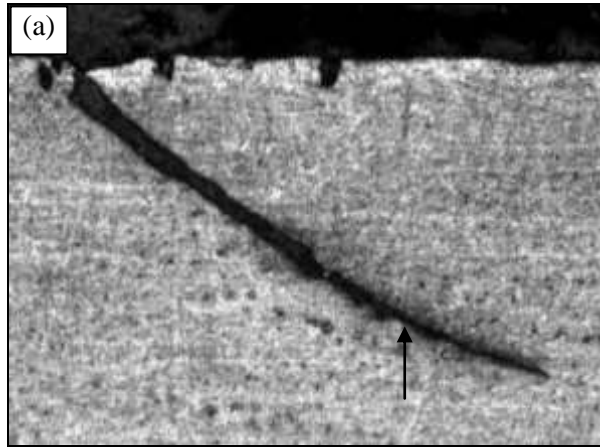
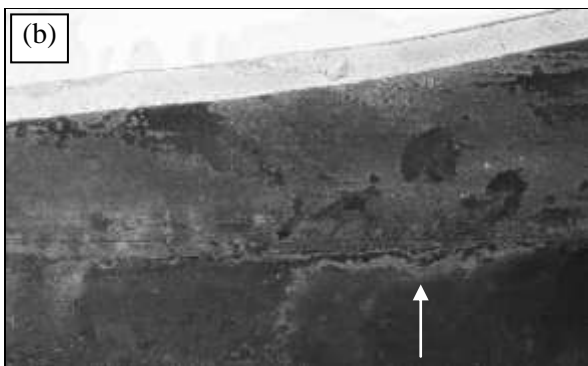
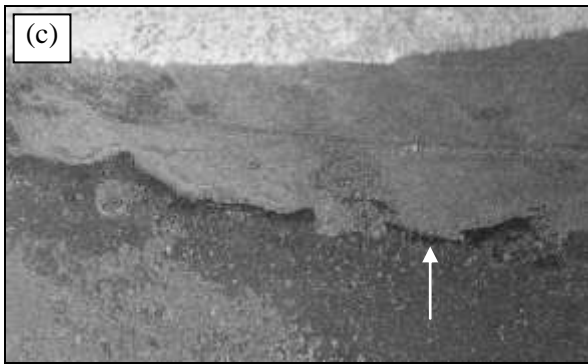
The ‘fold’ or ‘overlap’ shown in Fig. 4b, can also be seen in Fig. 6 as it appears on the inside surface of the cylinder. This fold, which is more than 1 mm deep, extends along almost the entire length of the cylinder. A fold of such depth can act as a highly effective ‘stress raiser’ in high pressure applications like a CNG cylinder [4-6]. For this fold, the stress concentration (SC) factor has also been calculated using Eq. (1) and the value is > 3.5 . This value of SC factor is very high, indicating severe stress concentration with such a fold at the operating pressure. This fault could not have been produced during the deep drawing, but was inherently present in the metal blank that was used for making this particular cylinder [7] and should have been detected during the inspection and quality control stages of manufacturing.

Fig.6 (b&c) Photographs showing the surface fold (or overlap) on the inside surface of the cylinder. Fig. 6a is the same as Fig. 4b.
