Cracking Failure in GAS-Turbine Blades

Liaqat Ali, Khalid M Ghauri, and Faizul Hasan *

University of Engineering & Technology, Lahore

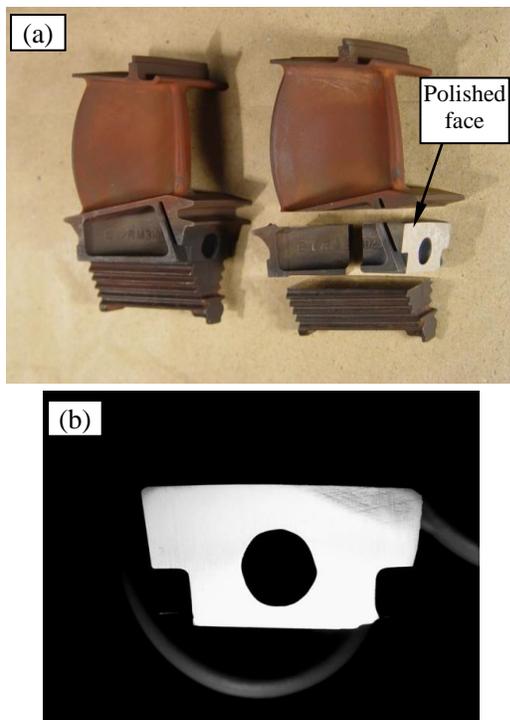
Photograph of the turbine Blades are given in Figure1. As may be noted in this photograph, a reddish-brown 'oxide' layer was present on the surface of the blades. Nevertheless no deposition of any foreign material was observed.

Figure 1: (a & b): Photograph illustrating the manner in which the Turbine Blades were sectioned for metallographic examination.

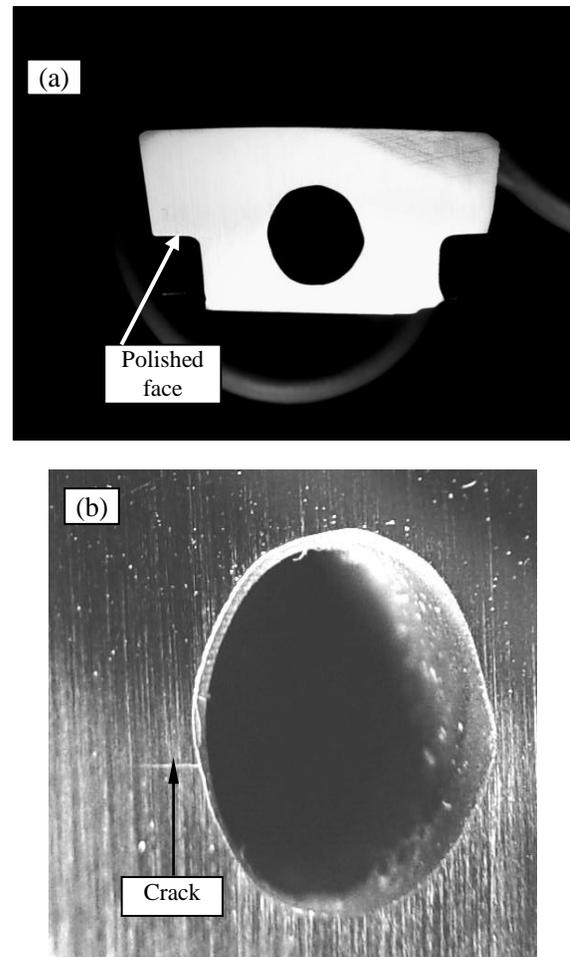
For metallographic examination, the blades were sectioned in a manner as illustrated from Figure1. The surface which was polished for metallographic examination is indicated by arrowhead. A photograph taken from semi-polished surface of Blade # 1 (Figure 2) shows a crack that could be easily seen with a low power magnifier. It may be pointed out that the crack seen in Figure 2b, was the only crack observed in Blade # 1.

Figure 2: (a & b): Photograph showing the location and orientation of cracks in Blade # 1. The crack became visible to naked eye even before the final stage of polishing.

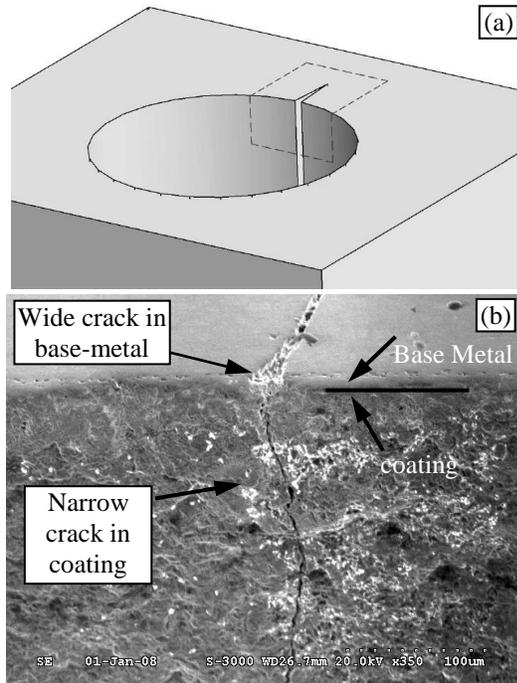
Figure 3: Scanning-Electron-Micrograph taken by tilting the specimen in such a manner that both the metallographically-polished surface as well as a part of the inside surface of the air-inlet hole could be seen. The scanned portion of the two surfaces which were essentially at right angle to each other are schematically illustrated in Figure 3a.

Scanning Electron Micrograph shown in Figure 3 (b) shows the crack. An important feature associated with the morphology of the crack in Blade # 1 is that the crack in the base metal is much wider than the crack in the coating (Figure 3b). It is very important to note that the crack exhibits its greatest width immediately beneath the coating.

This observation strongly indicates that crack did not initiate at the surface of the air-inlet hole, because if the crack was initiated by thermal stresses caused by cooling-air, it would be of a greater width at its starting point i.e., in the coating. Instead it is more logical to believe that the crack was present in the base metal before the coating was applied, and that the crack had grown into coating either during service or during the cutting and grinding of the blade for metallographic polishing. On the other hand, it can also be argued that these blades were refurbished, and that the coating was applied on blades that already had small cracks at the inlet of air-holes.

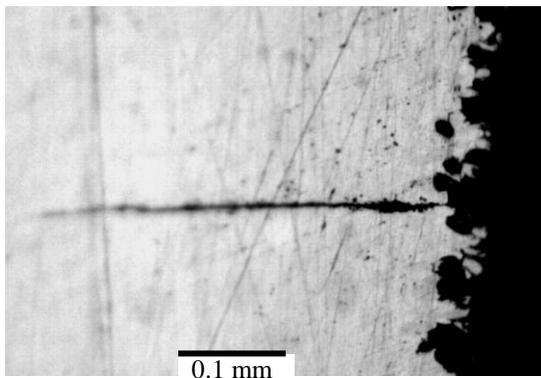
Figure 4: Optical Micrograph showing one of the four cracks in Blade # 2. The narrowness of the crack as it approaches the surface suggests that the crack had essentially formed beneath the surface.

The morphology of cracks observed in Blade # 2 provided support to the view that the cracks had actually formed in the base metal, at some stage (possibly before the coating was done), and then these cracks had extended into the coating from inside, either during service or during metallographic cutting and preparation. The occurrence of crack beneath the coating is evident in Figure 4, the crack becoming

thinner as it approaches towards the surface and ultimately discontinues before reaching the coating.

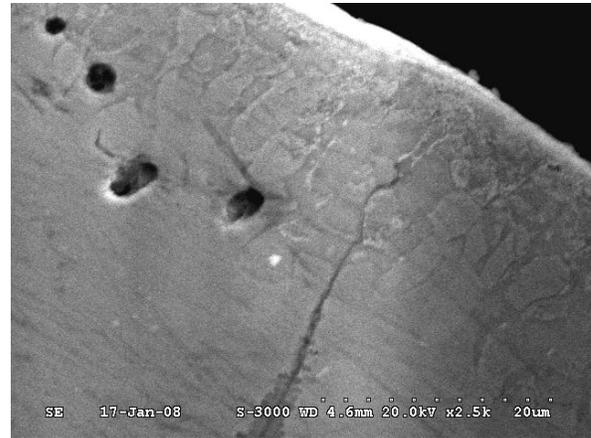
Figure 5: Scanning Electron Micrograph of the same crack shown in Figure 4. It is interesting to note in this micrograph that the coating does not exhibit any cracking at this stage.

A very convincing evidence that the cracks had formed inside the base metal, can be seen in Figure 5, where the crack is not connected to the outside surface, and also that the coating is still intact. This evidence again suggests that the crack had essentially formed beneath the surface, and therefore cannot be related to corrosion and hence not with corrosion fatigue.

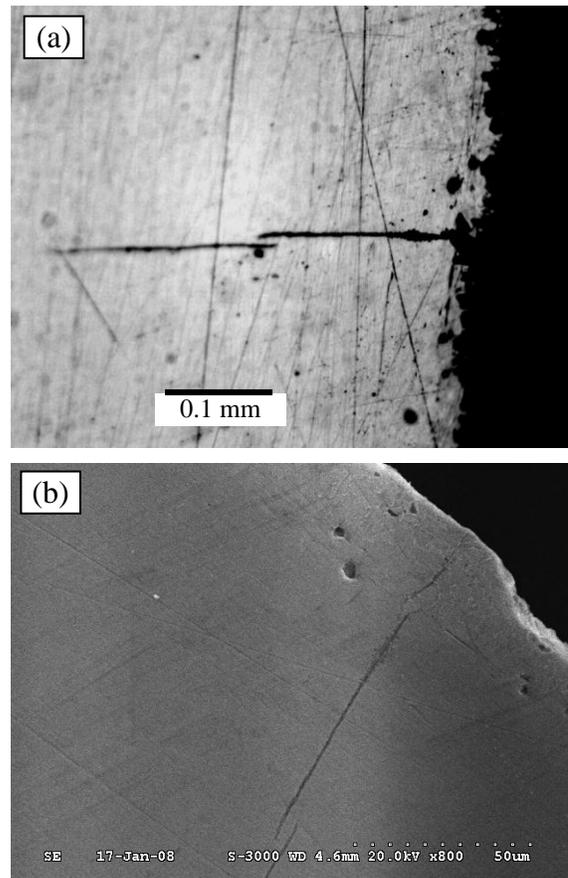
Figure 6: (a & b): Optical and Scanning Electron Micrographs taken from another location of Blade # 2, illustrating that the cracks are not exposed to surface, and hence cannot be related to corrosion fatigue. It may also be noted that in addition to the small crack just beneath the surface, there are two more independent sub-surface cracks.

Micrographs in Figure 6 (a & b) clearly illustrate that the pattern of cracking cannot be attributed to corrosion fatigue in which the crack has to originate at the surface (i.e., where a corroding agent is available) and then gradually extends into the interior under the influence of stress. Instead, the formation of more than one crack parallel to each other (normal to the direction of 'tensile' stress) is more consistent with cracking caused by solidification shrinkage.

The cracks seen in Figures 4-6 are of a morphology typical of subsurface solidification cracking caused by rigid cores. It may be noted in Figs. 5 and 6(b) that the crack is not even exposed to the surface. Further, it may be noted in Figure 6 that in addition to the small crack just beneath the surface, there are two more independent sub-surface cracks which are parallel but not connected to each other.
