Failure Analysis of a High Pressure Butt-Weld Flange

Abstract

2. Description of Failure

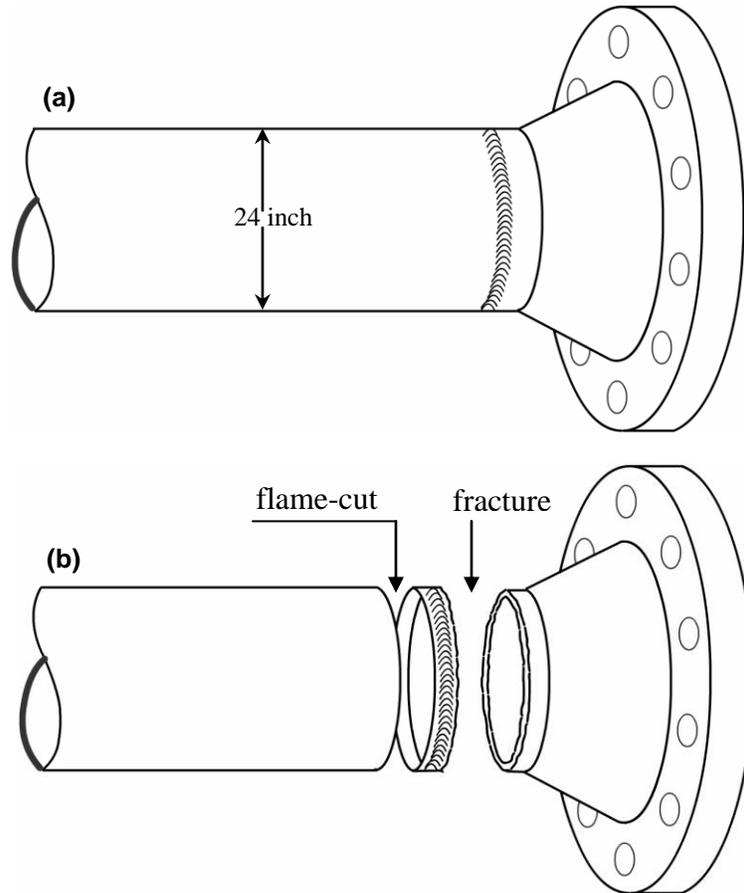
As a consequence of the rupture, the flange had completely separated from the pipeline. The cracking had apparently occurred through the heat-affected-zone (HAZ) on the flange side, as illustrated in Figure 1. Since the weld-joint was left with the pipe, a circular ring containing the weld-joint was cut off the pipeline with the oxy-acetylene torch so that a new flange could be welded to the pipeline at this place. The circular 'ring' containing the entire weld and the ruptured flange were provided to the authors of this paper for detailed failure analysis. Unfortunately, the fracture face on the flange had suffered from physical damage at many locations during transportation, and this may have resulted in a possible loss of useful evidence.

Figure 1: A schematic illustration showing the location of the fracture. It also shows the location at which the weld-joint was cut off the pipeline with the oxy-acetylene torch so that a new flange could be welded to the pipeline at this place.

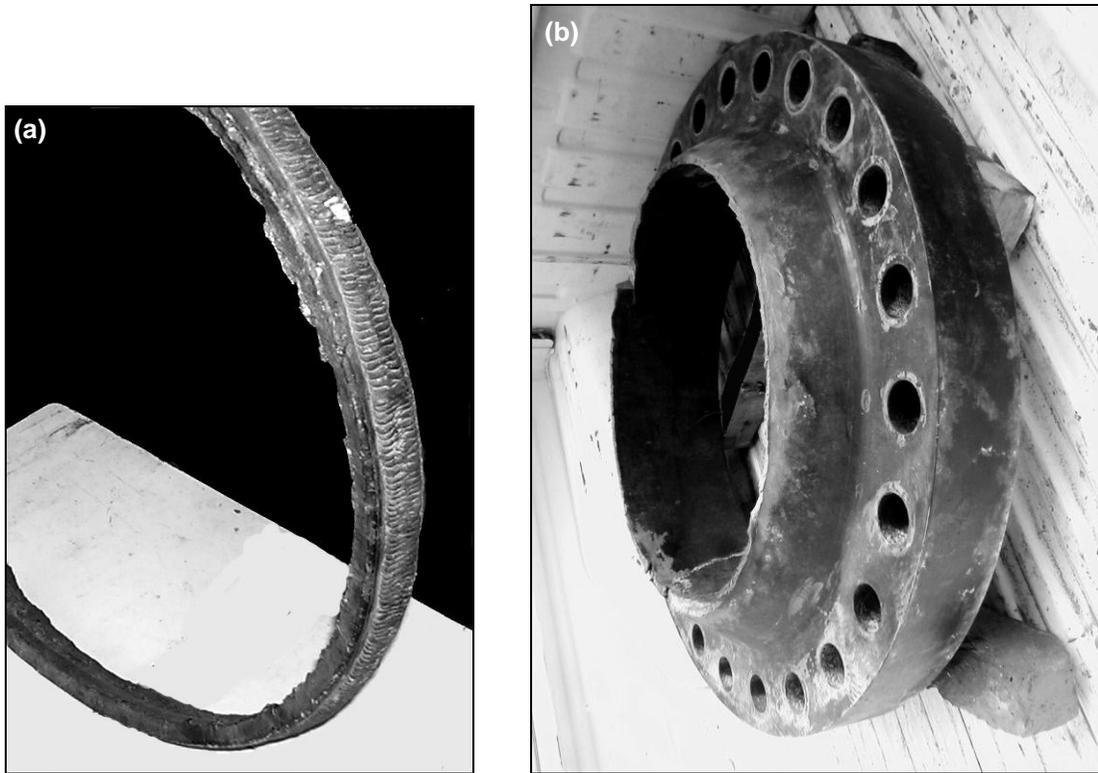
A detailed visual examination of the flange showed that the flange had parted along the circumferential weld apparently through the heat-affected-zone (HAZ) on the flange side. A photograph of the flange is given in Figure 2b, while a close-up view of the 'weld' in

Figure 2a. The circular ring containing the ‘weld’ (shown in Figure 2b) had been removed from the main pipe by gas cutting close to the weld.

Figure 2: The 24-inch diameter flange that had ruptured during hydrostatic testing (Figure 2b) along with a close-up view of the weld region that has been removed from the pipe by gas-cutting (Figure 2a).

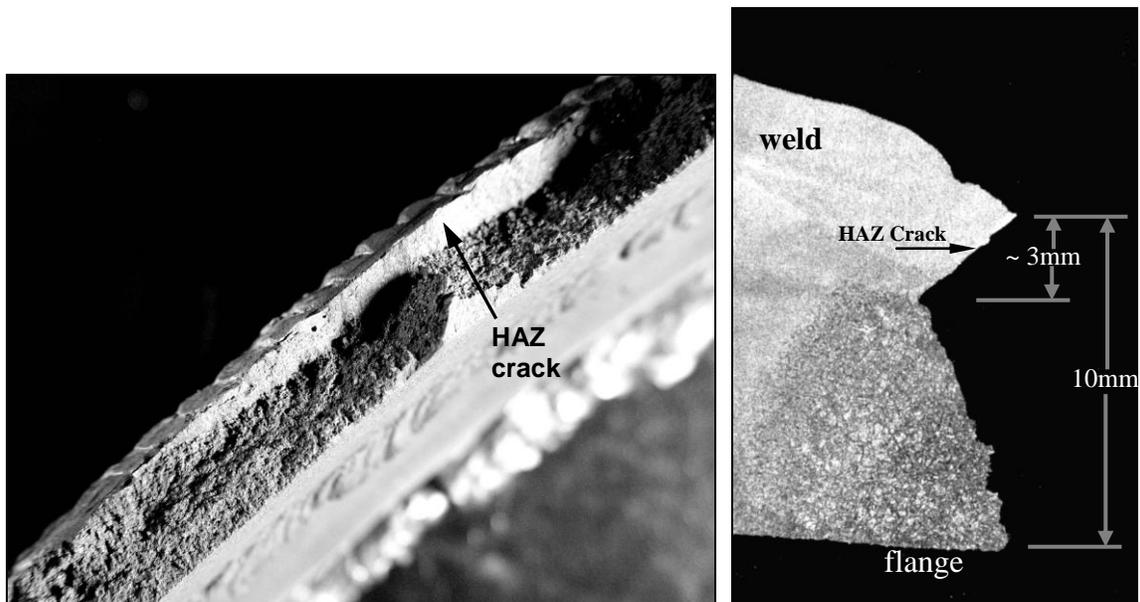
From the visual examination of the fracture surface on the circular ring, and with the help of the ‘chevron’ marks, the point where the fracture crack had initiated was identified; a close-up photograph of this region is shown in Figure 3a and a macro-section taken across the weld-line is shown in Figure 3b. It can be seen from these photographs that an approximately 2.7-3 mm deep portion of the crack with an essentially smooth fracture surface was oriented along the ‘Vee’ of the weldment / flange interface. This crack had all the characteristics of a HAZ crack that may form during the post-weld cooling. Additionally, as indicated by the chevron marks, it was this portion of the crack from which the fracture had initiated. These observations clearly

indicated that a crack, which was about 2.5-3 mm deep and about 50-60 mm long, had formed in the HAZ on the flange side during the post-weld cooling. A diagrammatic illustration of the HAZ crack is reproduced in Figure 4. Unfortunately, the fracture face on the flange, corresponding to the location seen in Figure 3a, had suffered from physical damage during transportation, and was of little use to present investigation.

Figure 3: (a) The region of fracture initiation in the HAZ on the flange side of the weld. (b) A macro-section taken across the weld line of the sample shown in (a).

The morphology of the HAZ crack, as seen in Figure 3, is similar to that of hydrogen-assisted cracking, and also to cracks which may form at stress-concentration sites (under-cut) at the weld roots. Whereas it is possible that the stress concentration at the weld root

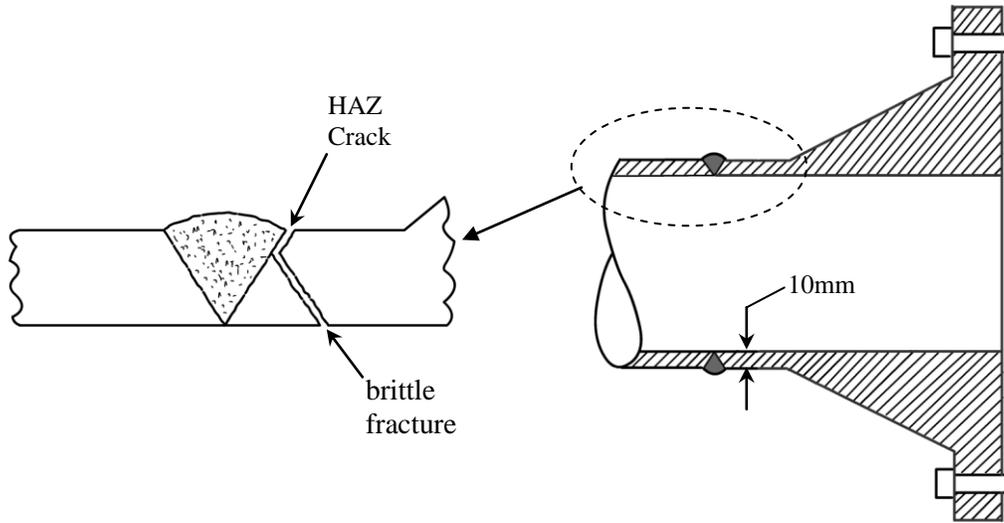
Figure 4: A diagrammatic illustration of the orientation and location of initial crack with respect to the weld.

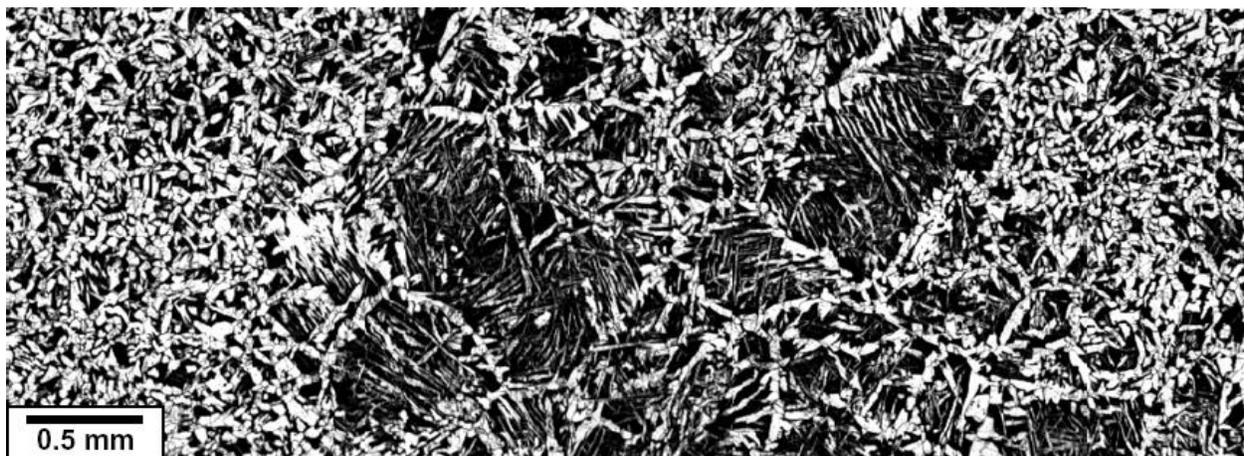
microstructure. The macroscopic examination did not reveal any such feature (e.g., any in-appropriate grain flow or large non-metallic inclusions) that could be objected against. However, the microscopic examination showed that the microstructure was somewhat inhomogeneous in terms of the distribution of pearlite. A low-magnification view illustrating the microstructural heterogeneity is shown in Figure 5.

regions were typically 2.5-3 mm across, and were sporadically distributed in the microstructure. It was important to note that these coarse-grained pearlite-rich patches were comparable in size with the depth of the HAZ crack (i.e., ~2.5-3 mm) as can be seen in Figure 3b.

Figure 5: A low magnification panoramic view of the Flange Steel showing a sporadic distribution of large-grained pearlite-rich areas in the microstructure.

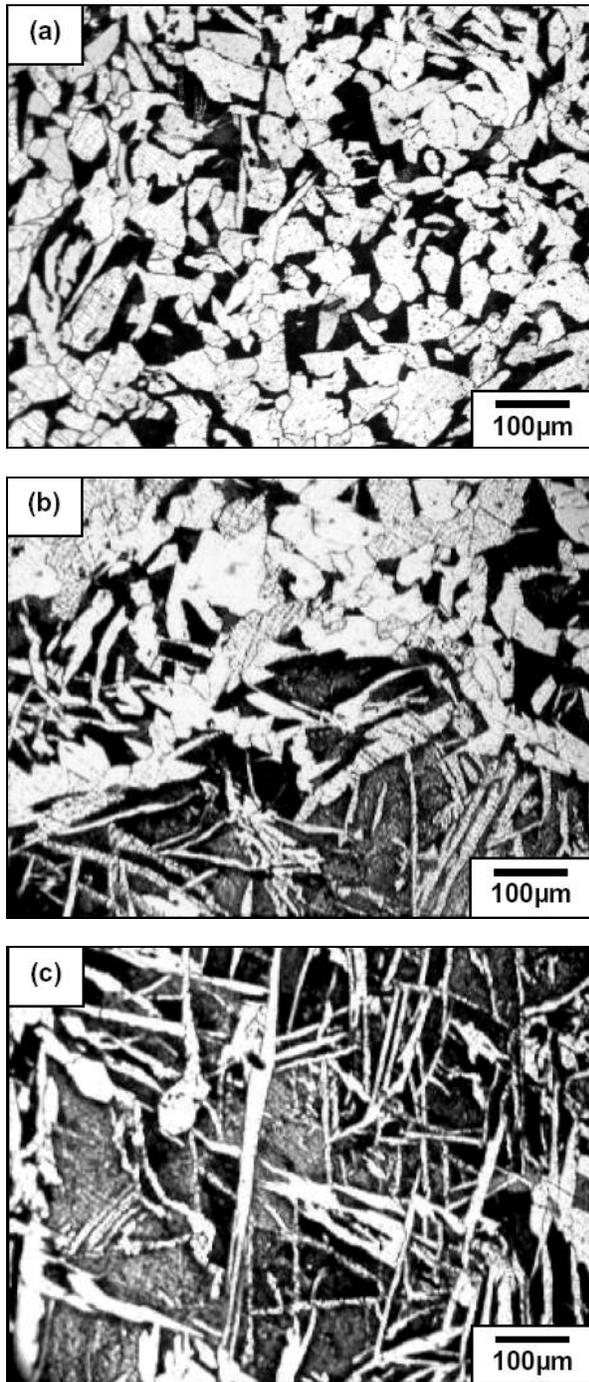
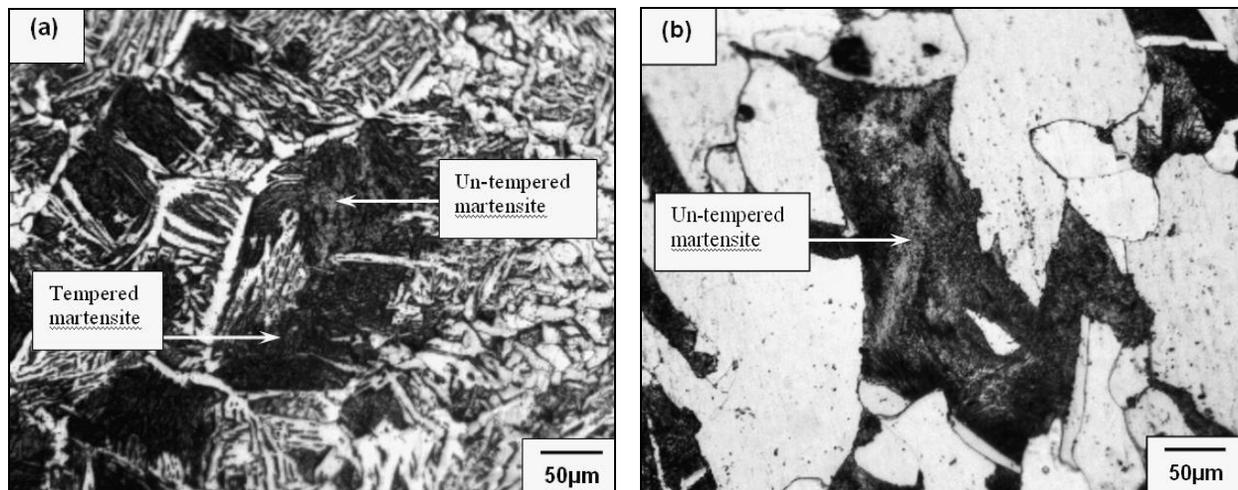
Selected micrographs taken from the sample are given in Figure 6. The microstructure shown in Figure 6(a) was the typical microstructure observed at most places in the welding-neck area of the flange. This microstructure which comprised about 25-30% pearlite and 70-75% ferrite, was consistent with an approximately 0.25% carbon steel, i.e., the value of the carbon-content as determined through the chemical analysis given in Table 1. The grain size measured at locations similar to the one shown in Figure 6a, was comparable with ASTM size 3.5.

However, an odd feature observed in the microstructure of the flange was the presence of pearlite-rich 'patches' in the microstructure, such as the one shown in Figure 6 (b and c). The microstructure of Figure 6c taken from a pearlite-rich region shows this region to be predominantly composed of the pearlite phase with only about 20-25 % ferrite. The microstructure of Figure 6b which was taken from the edge of a pearlite-rich area illustrates sharp and distinct changes in the level of pearlite-content across the microstructure.

Figure 6. Microstructures taken from a small piece cut from the ‘welding-neck’ of the flange. Fig 6(a) shows the typical microstructure observed at most places in the welding-neck area of the flange, while Figs 6(b and c) show the presence of large grained pearlite-rich regions in the microstructure.
