Failure Investigation of a Wheel Type Ride

Abstract

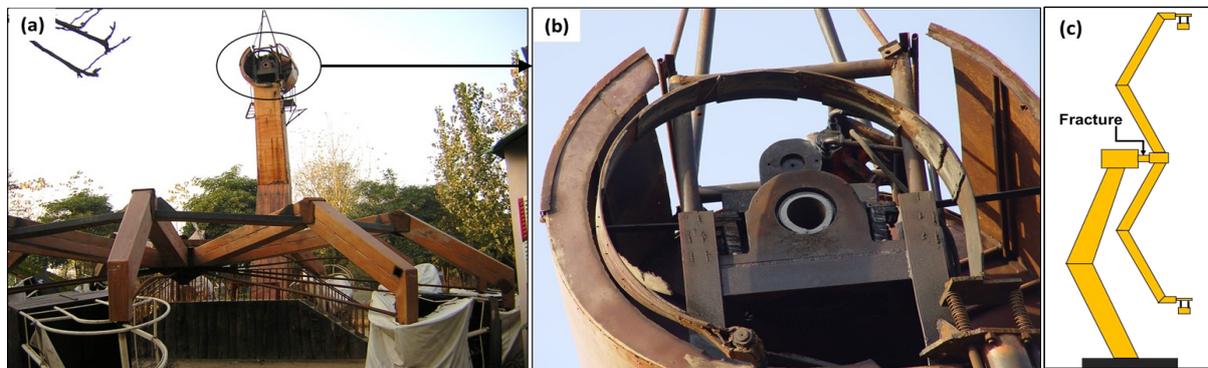
park informed that the ride was installed just two weeks before this unfortunate incident had happened. Fig. 1(a) shows the picture of this unhappy event, while in Fig. 1(b) the magnified view of the broken shaft can be seen, and Fig. 1(c) presents the geometrical drawing of the giant ride. The giant ride had a diameter of 42 feet that revolved in the upright-plane.

Fig. 1: (a) Photograph of the broken ride, taken few days after the event took place, (b) magnified view of the broken shaft, and (c) a drawing of the huge ride showing its main components

Visual inspection of the debris of the incident indicated that the accident might have happened due to a crack which could have eventually caused the failure of the shaft, while a substantial loss occurred to the cradles and the metal structure. Therefore, metallurgical inspection of the material of the shaft as well as the rupture mode became the prime considerations for this failure investigation.

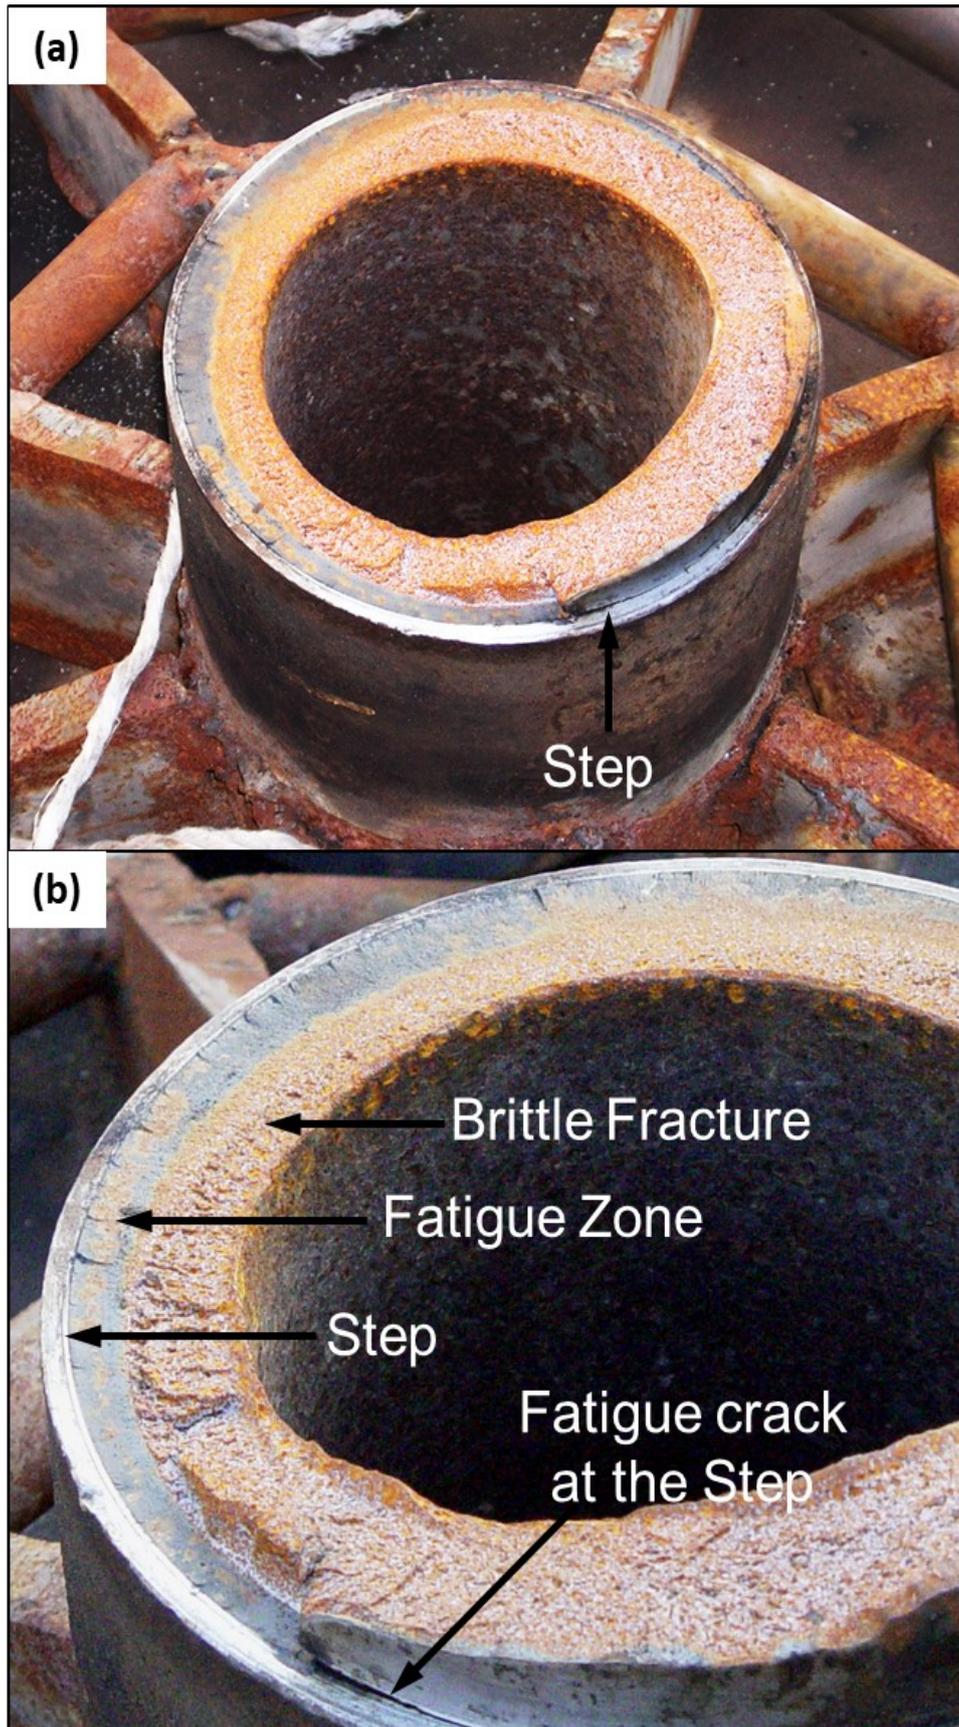
It was observed that the shaft of the Giant Wheel had failed due to rotational bending that caused fatigue fracture [11]. There was a crack 0.315–0.394 in. (8-10) mm deep on the circumference of the shaft. Photos shown in Fig. 2 illustrate the fracture on surface, wherein, the arrowheads point to the portion which has brittle fracture and fatigue regions. It was observed from the fractured surface that the fatigue-crack region was grey in color, whereas the brittle fracture was of reddish brown color, majorly due to metallic rust. Unlike the brittle region, the fatigued region was oily. It was a clear indication that the lubrication had seeped inside the fatigue crack, and this oil had acted as an anti-rusting agent.

Fig. 2 (a) shows that the shaft was machined with a step (sudden reduction in

diameter). Fig. 2(b) shows a portion of the crack running through the inner side of the step. The disastrous failure of the middle shaft was due to the same crack. It was noticed that the sharp-step on the middle-shaft was present at the point where the bending moment was maximum i.e. at the most critical point. Fig. 3 shows that how the existence of the sharp step on the middle shaft had made it very dangerous.

Fig. 2: Fractured face of middle-shaft showing: (a) the 'step' from where the fracture had started and (b) Various phases of crack-propagation

The step was very sharp (as shown in Fig. 2) with a depth of 0.177-0.197 in. (4.5-5 mm). But for the approximation of stress concentration factor (with reference to Fig. 4), the radius of curvature 'r' was taken equal to 0.0394 in. (1 mm) approximately at the root of the shaft, and the external diameter of the shaft was used as 8 in. (D = 203 mm). Using these values;

Sudden decrease in diameter of shafts is extremely objectionable and should be avoided lest there is no alternative, and sharp edges should be

replaced by fillet radius or through proper chamfering. In this incident the shaft was machined to a smaller radius in order to fit the available ball bearings in it, which became a very serious mistake in the manufacturing process.

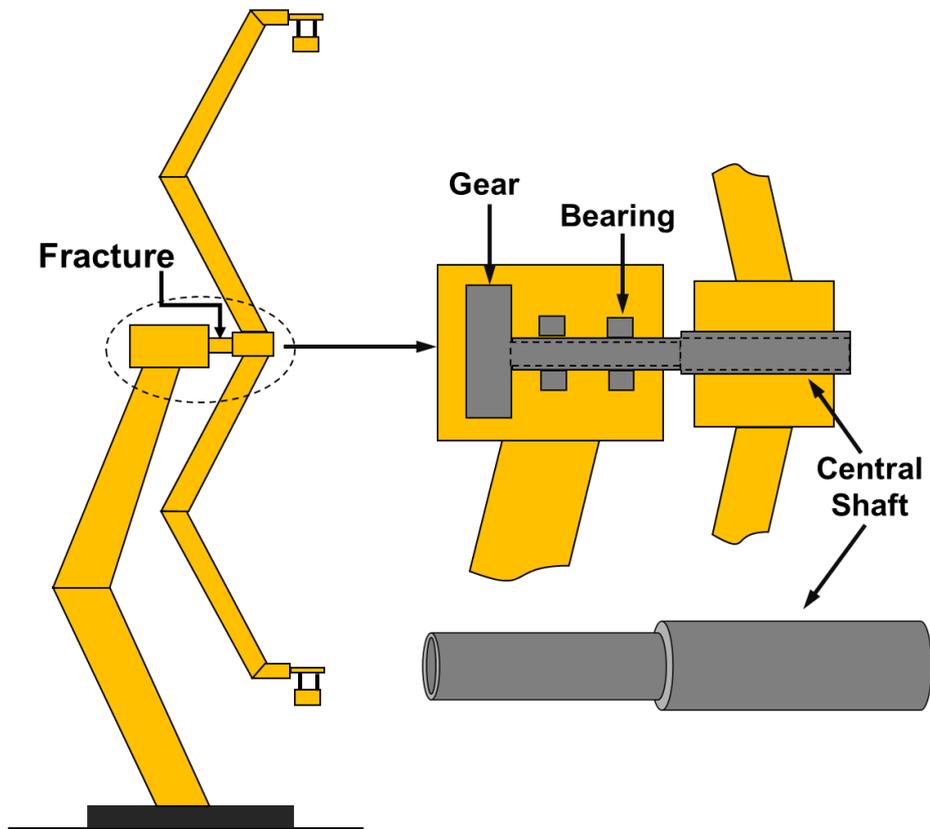
Fig. 3: Schematic diagram of the middle shaft and the components attached to it

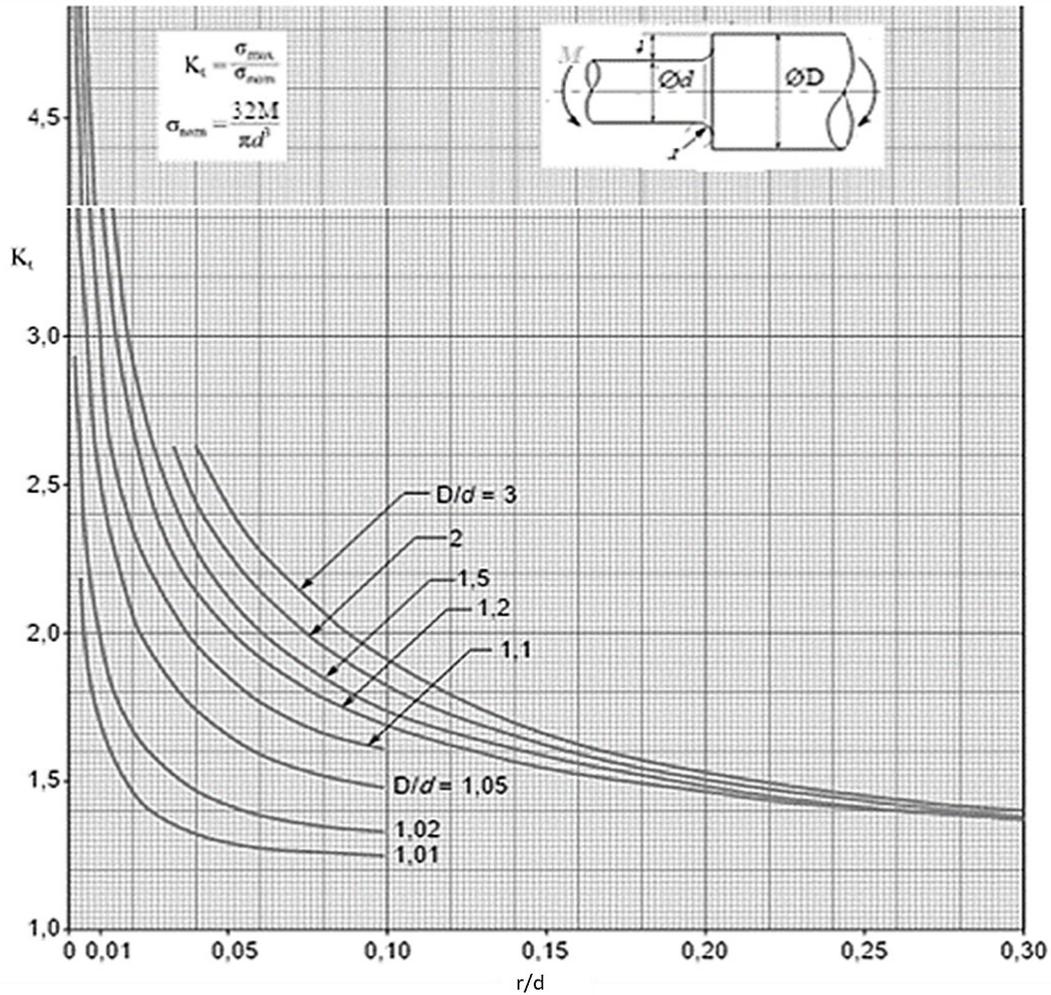
Using above data, the stress-concentration factor was calculated using the graph given in Fig. 4. The graph shows that the stress-concentration factor increases exponentially with the decrease in r/D value. The graph shows that in the current case the stress-concentration factor was approximately 3.

Fig. 4: Stress concentration factor versus diameter ratio [12]

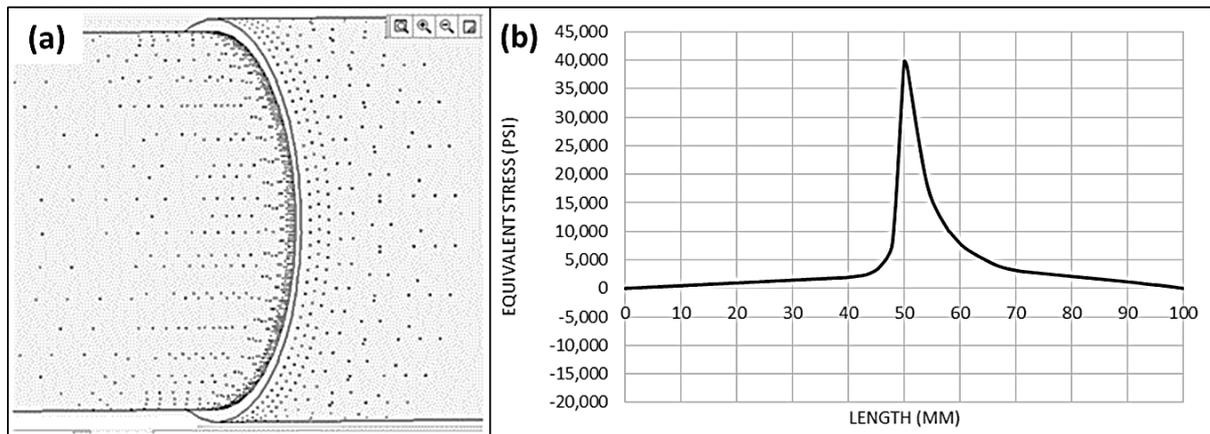
Total moment of 756000 lb-in (as suggested in structural analysis) was applied on one side of the shaft keeping the other side fixed. Maximum stress of 39763 psi (20 tons/in²) was achieved at the step (see Fig. 5) which was same as calculated in structural analysis (i.e., 20-25 tons/in²). Density of dots is showing the variation of stresses at different points along the length of the shaft.

Fig. 5: Variation of stresses along the length of 8 in. diameter shaft as calculated using ANSYS workbench

When the sharp edge was replaced by a smooth round curve, the stress was reduced to 22 tons/in² which is still very high. Previously the factor of safety (FOS) was kept equal to 1.5 which

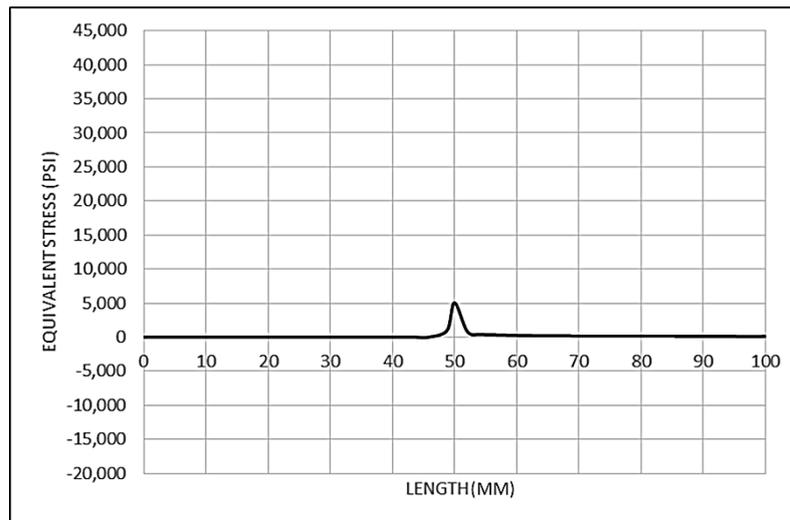
Fig. 6: Reduced stresses due to thicker shaft of 16 in. diameter as calculated using ANSYS workbench

was extremely low. As a result of the present analysis, it was suggested to increase the FOS to approximately 10 and the new diameter of the shaft for the safe operation of ride was proposed to be 16 in. Analysis of 16 in. diameter shaft showed that the stresses were reduced to a safe level of just 5036 psi (03 ton/in²) as shown in the graph of Fig. 6.
